City of Richmond

Report to Committee

To: General Purposes Committee **Date:** September 30, 2019
From: Cecilia Achiam **File:** 12-8080-12-01/Vol 01
General Manager, Community Safety
Re: **Non-Farm Use Fill Application for the Properties Located 11300 & 11340
Blundell Road (Athwal & Yau)**

FILL PLACEMENT PLAN - REVISED

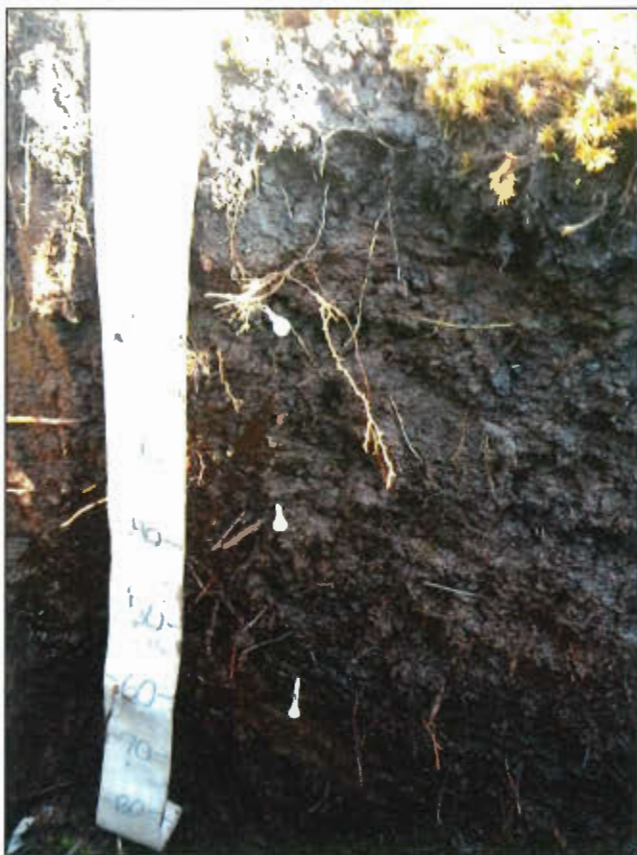
MA-01 Soil Profile Description

<u>Horizon</u>	<u>Depth (cm)</u>	<u>Description</u>
Op	0 - 16	Black (10YR2/1 m); very strongly decomposed sphagnum, strong, medium subangular blocky structure; friable when moist; plentiful coarse and few fine roots; abrupt, smooth boundary.
Om	16 - 33	Dark brown (10YR 3/3 m); moderately decomposed sedges and reeds; weak, fine platy structure; friable when moist; plentiful coarse and few fine roots; abrupt, smooth boundary.
Of	33 - 56	Dark yellowish brown (10YR 3/6 m); almost undecomposed sphagnum with 10% to 20% hard wood fragments; plentiful coarse and very few, fine roots, abrupt, smooth boundary.
Of	56 - 90+	Dark brown (10YR 3/3 m); almost undecomposed sedges and reeds; friable when moist.

Typic Fibrisol. The watertable is at 33 cm in the pit.

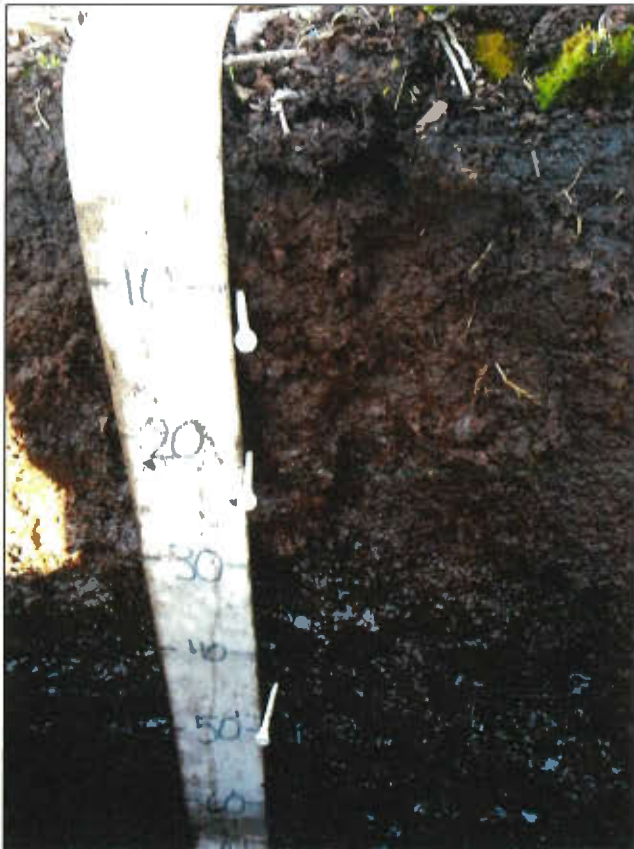
MA-02 Soil Profile Description

<u>Horizon</u>	<u>Depth (cm)</u>	<u>Description</u>
Op	0 - 12	Very dark brown (10YR 2/2 m); almost completely decomposed; few fine roots; abrupt smooth boundary.
Om	12 - 22	Very dark grayish brown (10YR 3/2 m); moderately decomposed sedges and reeds; few fine roots; abrupt, smooth boundary.
Om	22 - 46	Very dark grayish brown (10YR 3/2 m); strongly decomposed sphagnum; abrupt smooth boundary;
Of	46 - 75+	Dark yellowish brown (10YR 4/4 m); almost undecomposed sedges and reeds.

*Typic Fibrisol.*

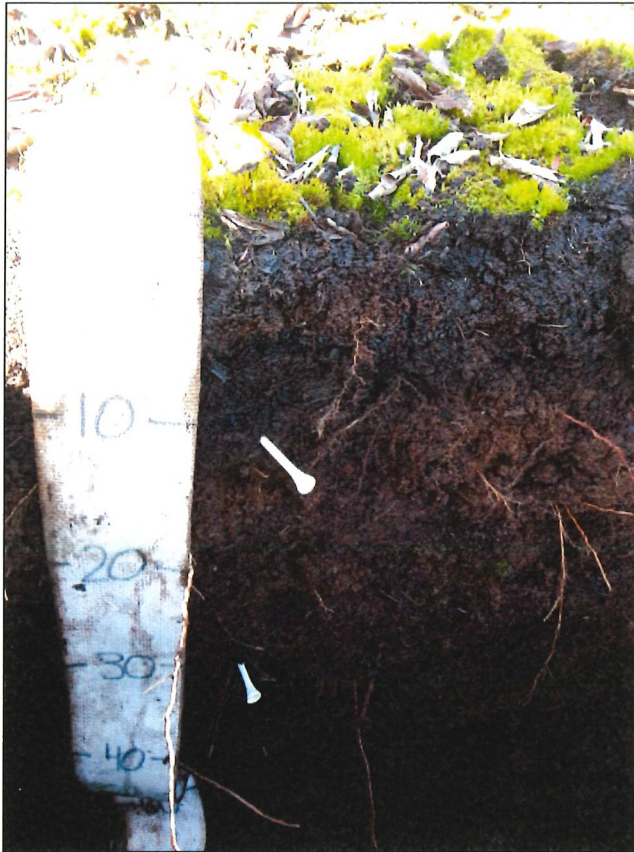
MA-03 Soil Profile Description

<u>Horizon</u>	<u>Depth (cm)</u>	<u>Description</u>
Op	0 - 12	Black (10YR 2/1 m); few coarse roots; abrupt smooth boundary.
Of	12 - 34	Dark yellowish brown (10YR 3/6 m); slightly decomposed sphagnum; few coarse and plentiful fine roots; abrupt smooth boundary.
Of	34 - 63+	Dark brown (10YR 3/3 m); weakly decomposed sedges and reeds; few coarse roots.

Upper horizons of a Typic Fibrisol.

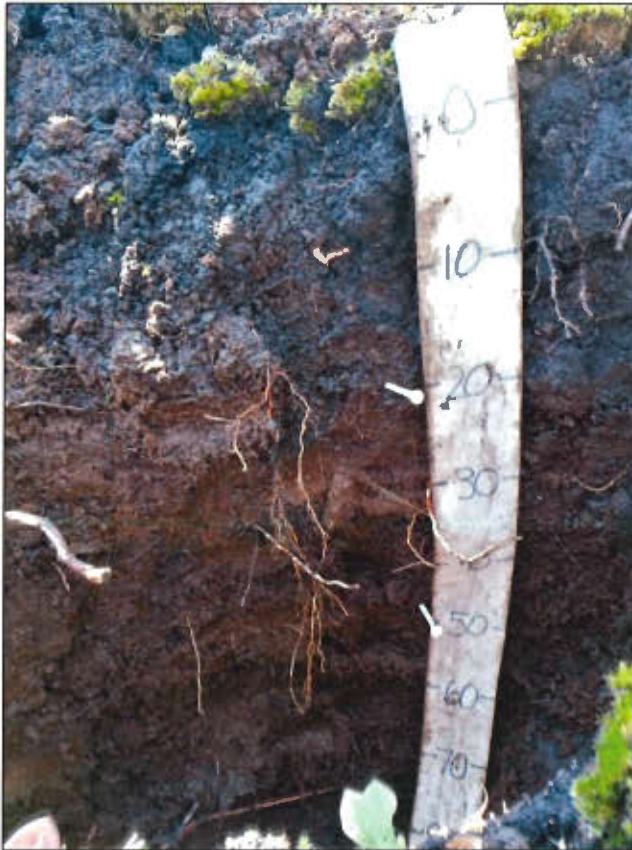
MA-04 Soil Profile Description

Typic Fibrisol, similar to the Triggs soil series.

- Rooting depth is 47 cm.
- Watertable at 56 cm.

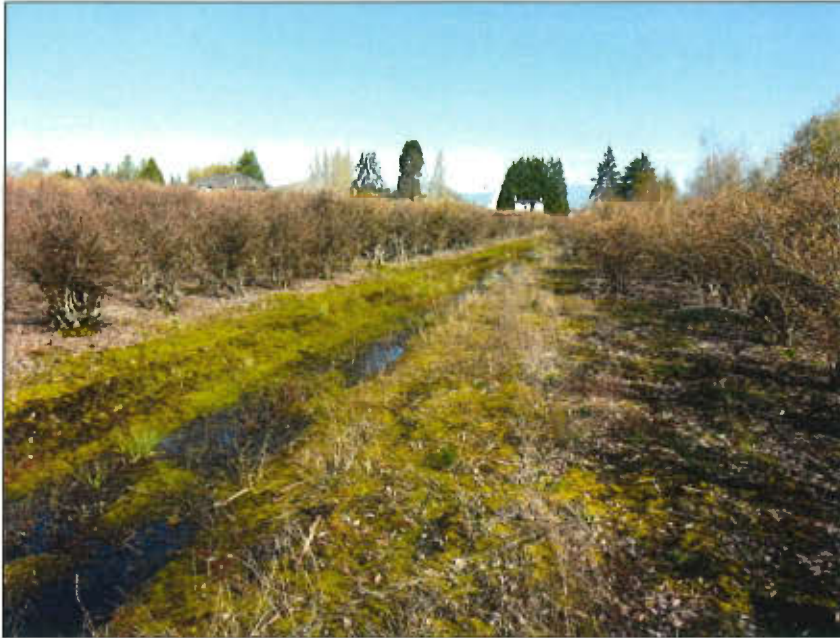
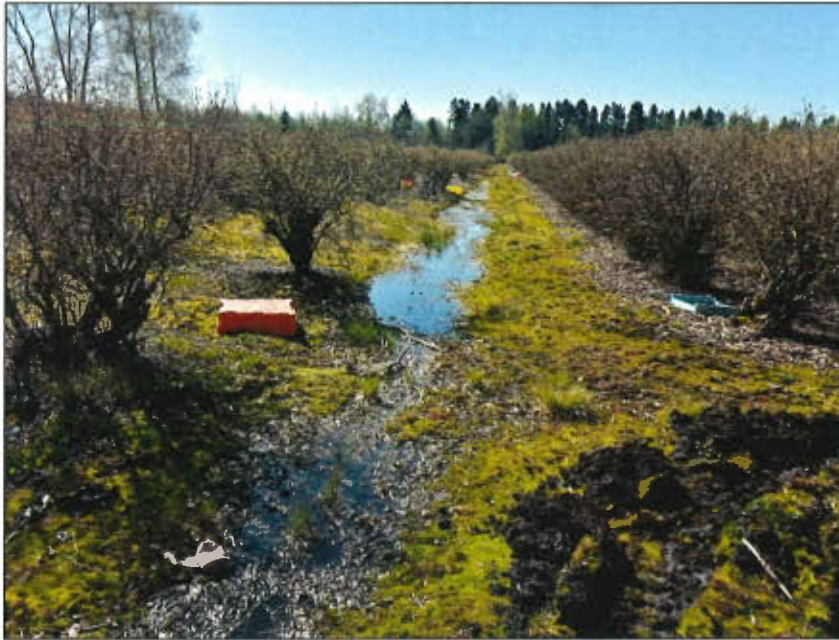
Site photos. Photo 1 is the view north from the access road that approximately follows the boundary between the two properties. Photo 2 is the view south. Note water pooling on the road and the tracks left by the mini-excavator used to dig the soil pits. The height, age, and spacing of the blueberries leaves them unsuited to mechanical harvesting.
