# City of Richmond

## Report to Committee

**To:** General Purposes Committee **Date:** June 9, 2020  
**From:** Cecilia Achiam **File:** 12-8080-12-01/Vol 01  
 General Manager, Community Safety  
**Re:** **Soil Use for the Placement of Fill Application for the Property Located at 5800 No. 7 Road (Mahal)**

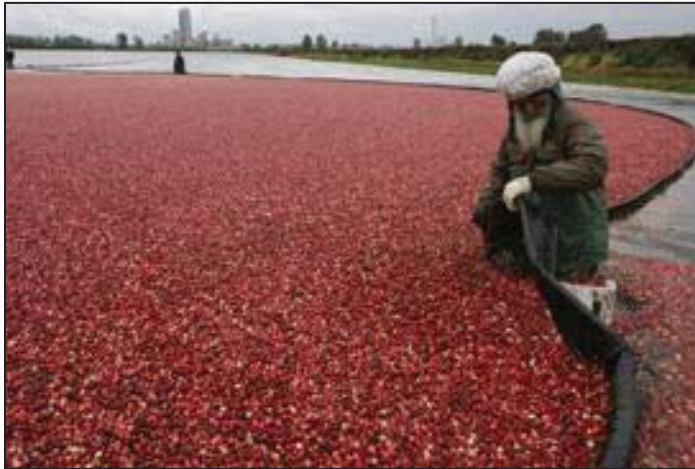
**PHOTO 1. WET HARVEST OF CRANBERRIES ON THE PROPERTY. DATE OF PHOTO UNKNOWN, VIA THE BC CRANBERRY MARKETING COMMISSION<sup>2</sup>.**

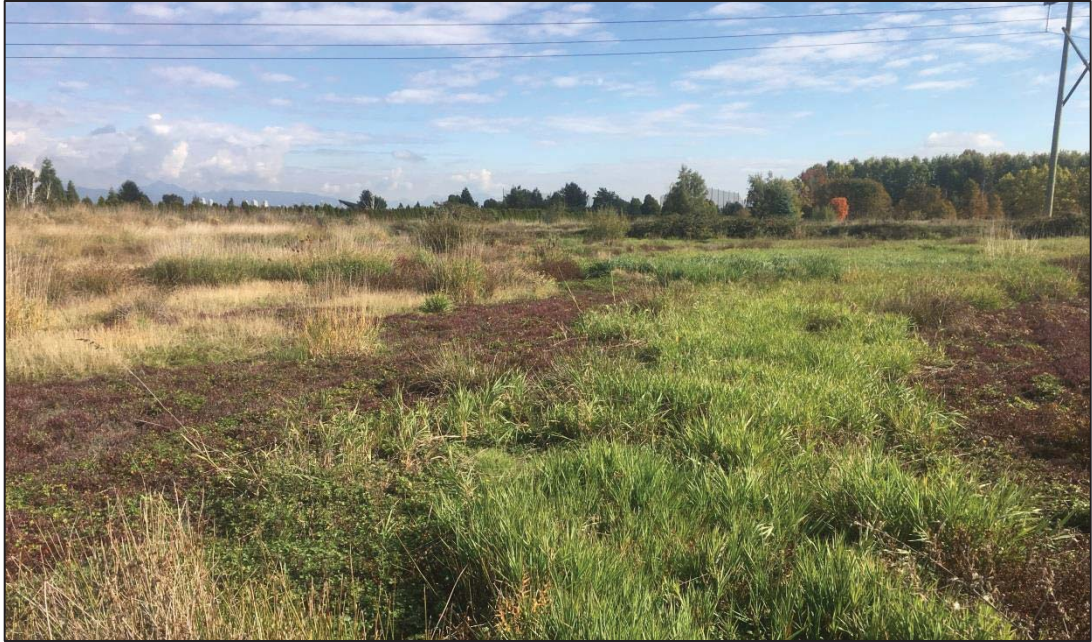
**PHOTO 2. LOOKING DUE EAST ACROSS THE FORMER CRANBERRY BOG. THIS PHOTO IS FROM EARLY OCTOBER DURING A PARTICULARLY WARM AND DRY PERIOD.**

The northwest corner of the property was previously farmed for cranberries. The cranberries were sold in the Ocean Spray cranberry collective (**Photos 1 and 2**). To facilitate cranberry farming, there are berms (or dykes) established around the perimeter, as well as an irrigation canal/ditch on the south side of the proposed farm area (to flood the field as a wet harvest). As a legacy of cranberry farming, the native soil was found in our soil testing to be very acidic and severely deficient in both nitrogen and phosphorous. Another legacy of this farming activity is the diversity of mulches that were placed on the soil, including wood chips and sand.

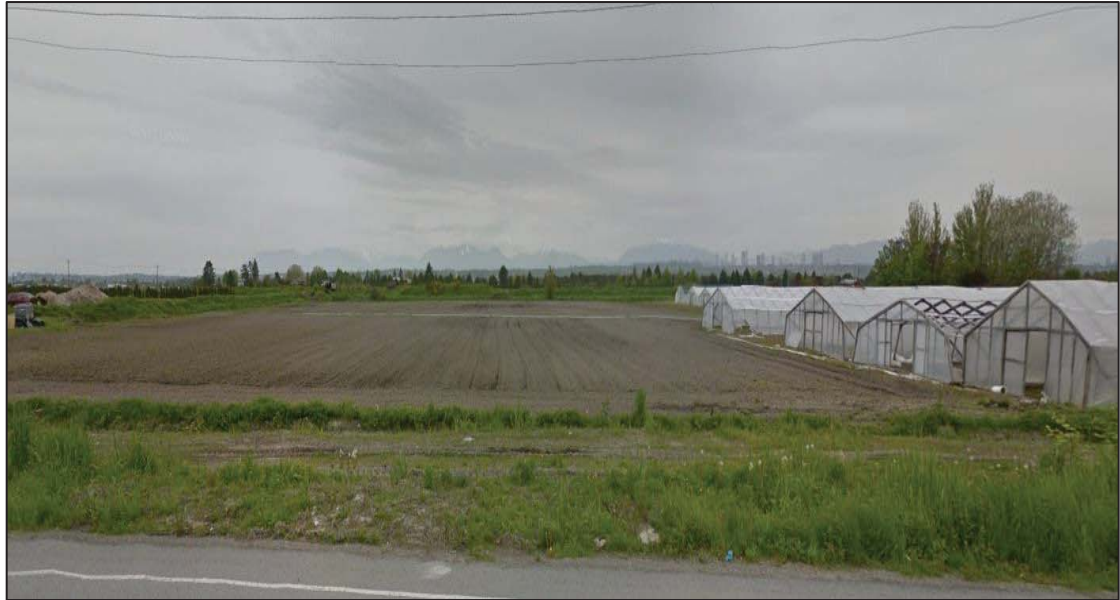
**PHOTO 3. PANORAMIC VIEW OF THE FIELD AND GREENHOUSES SITUATED JUST WEST OF THE CENTRE OF THE PROPERTY AT WESTMINSTER HIGHWAY. THIS IMAGE IS FROM 2017 VIA GOOGLE™ MAPS.**

The remaining southern half of the property is actively farmed by either Mahal Farms or is leased to local farmers. The current farming uses reported by Mahal Farms are vegetables (field and greenhouse), hedging cedar (field-based near No. 7 Road), and tree nurseries (container and caliper trees). A 2018 Google™Earth Pro image shows that at least 0.75 ha of the property is occupied by greenhouses, situated in the approximate centre of the southern portion of the lot (**Photo 3**).

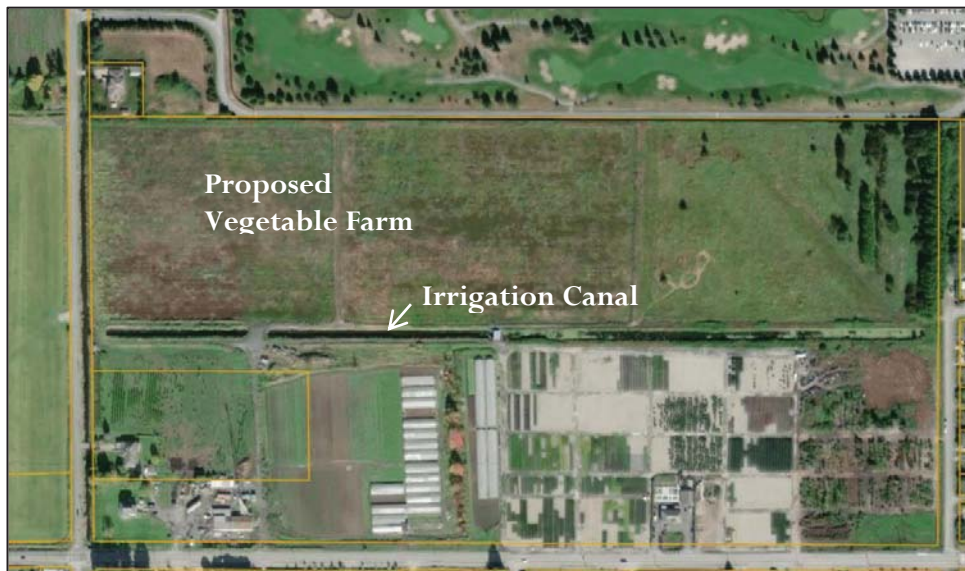
**FIGURE 1. IRRIGATION CANAL SITUATED THROUGH THE CENTRE OF THE PROPERTY. OVERHEAD SPRINKLER SYSTEMS AND DRIP IRRIGATION CAN BE CONNECTED TO THIS. MAP IMAGERY FROM IMAPBC 4.0.**

The property has a large, approximately 10 m wide irrigation canal that runs through the approximate centre (**Figure 1**). This canal also has a pump house. There is thus adequate water for irrigation needs on site. Nearby ditches on No. 7 Road and Westminster Highway are kept artificially high by the City of Richmond during the summer and early fall.

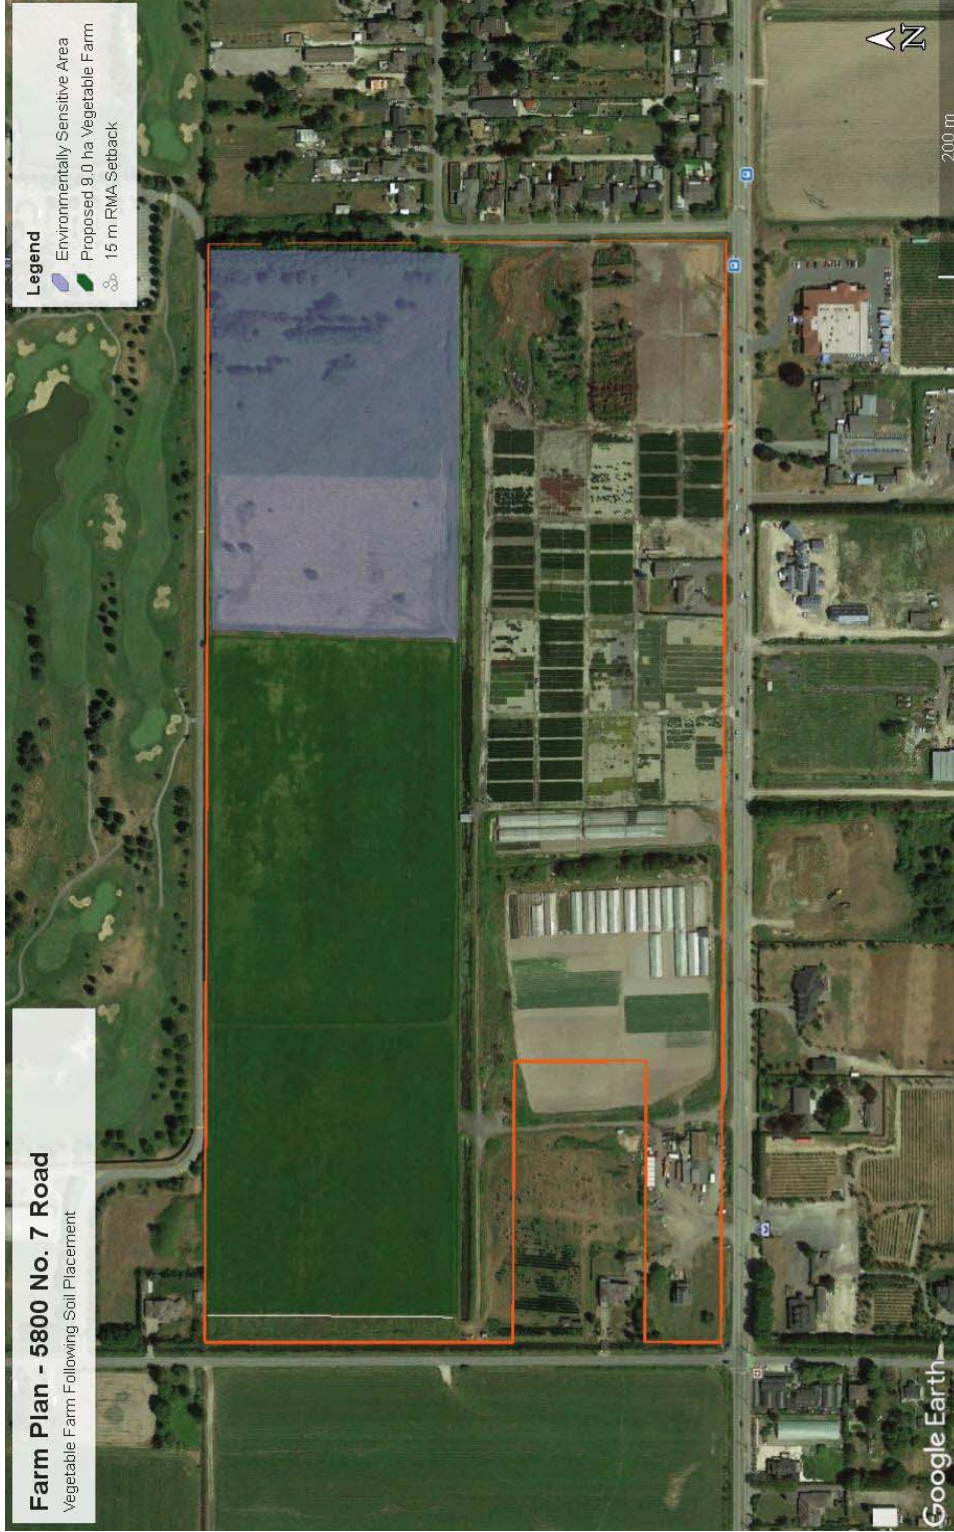
FIGURE 1. OVERVIEW OF 5800 NO. 7 ROAD ON GOOGLE™ EARTH PRO. THE 15 M RIPARIAN MANAGEMENT AREA (RMA) SETBACK FROM THE NO. 7 ROAD DITCH IS SHOWN, AS IS THE ENVIRONMENTALLY SENSITIVE AREA (ESA) IN THE 5.1 HA RECTANGLE IN THE NORTHEAST CORNER OF THE PROPERTY. THE VEGETABLE FARM AREA IS 9.0 HA.

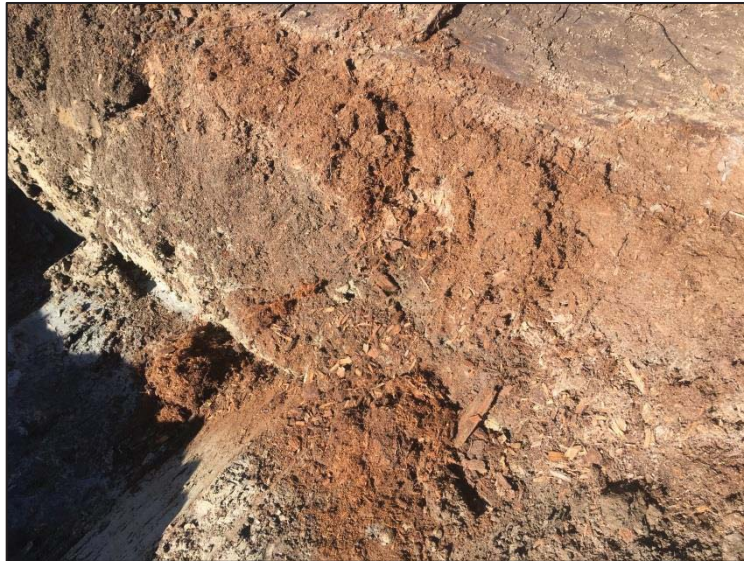
**PHOTO 3. WOOD SHAVINGS PRESENT AT THE TOP OF THE AH LAYER IN SOIL PIT 7.**

These were brought in for the cranberry farm previously located here. Cranberries have not been harvested since 2016. We did not observe these shavings anywhere else on the property during our assessment.

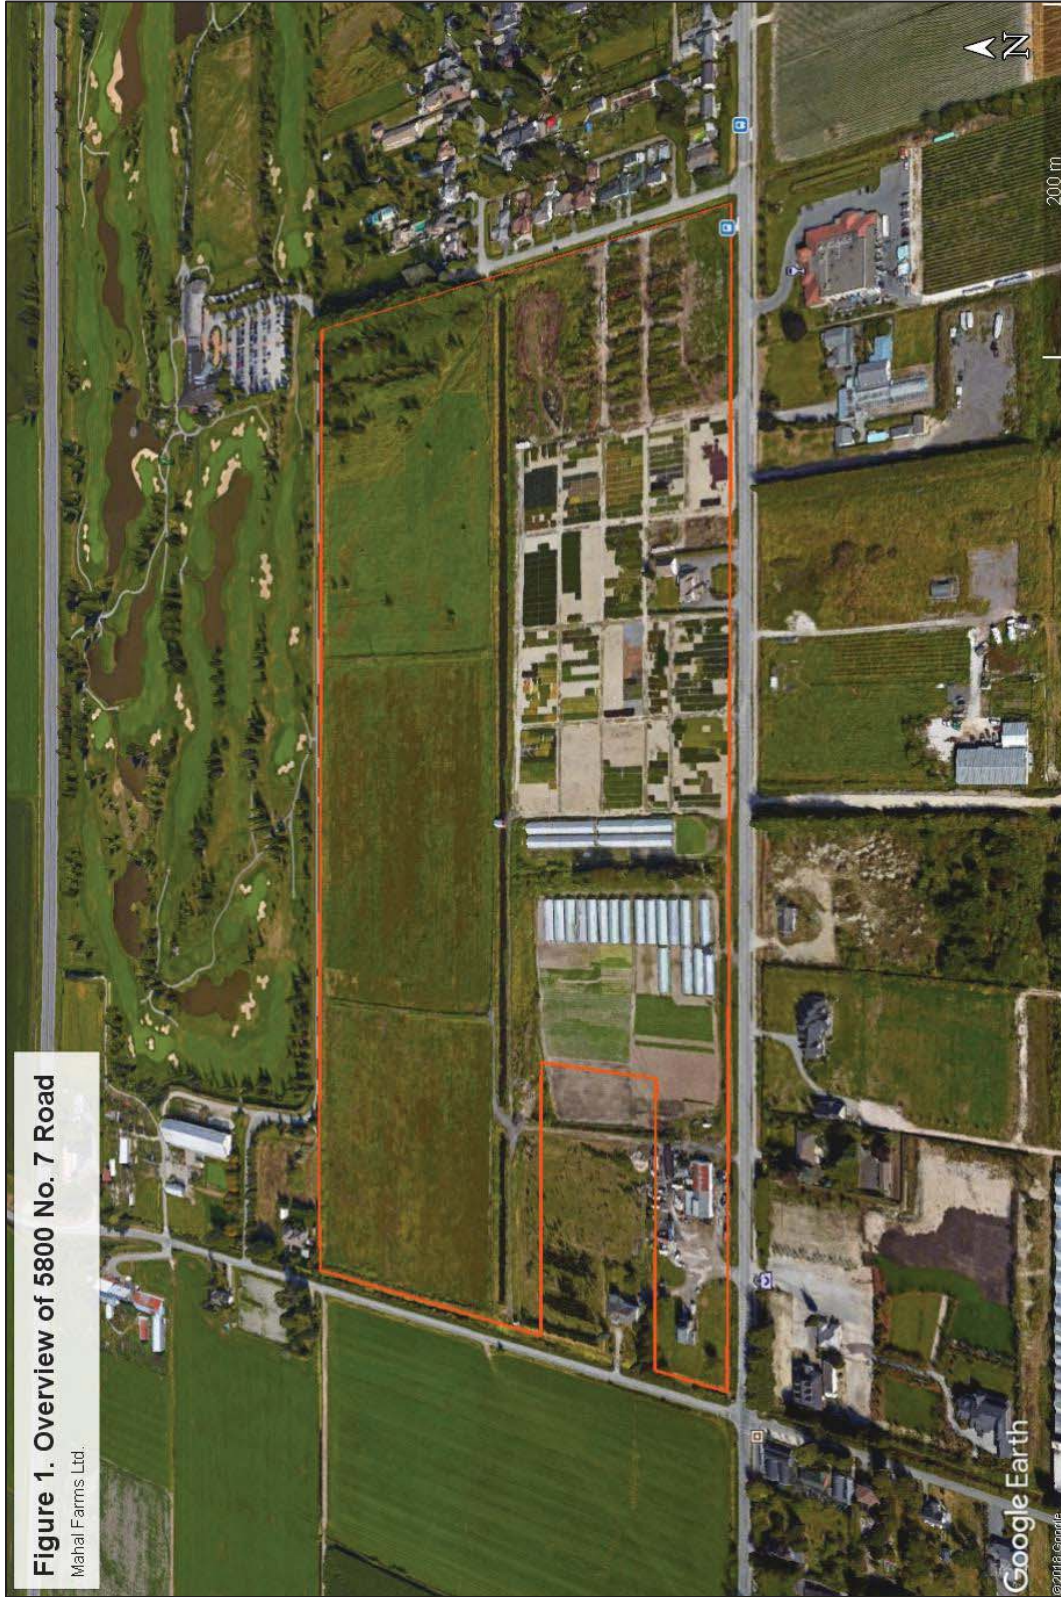
FIGURE 1. OVERVIEW OF 5800 NO. 7 ROAD

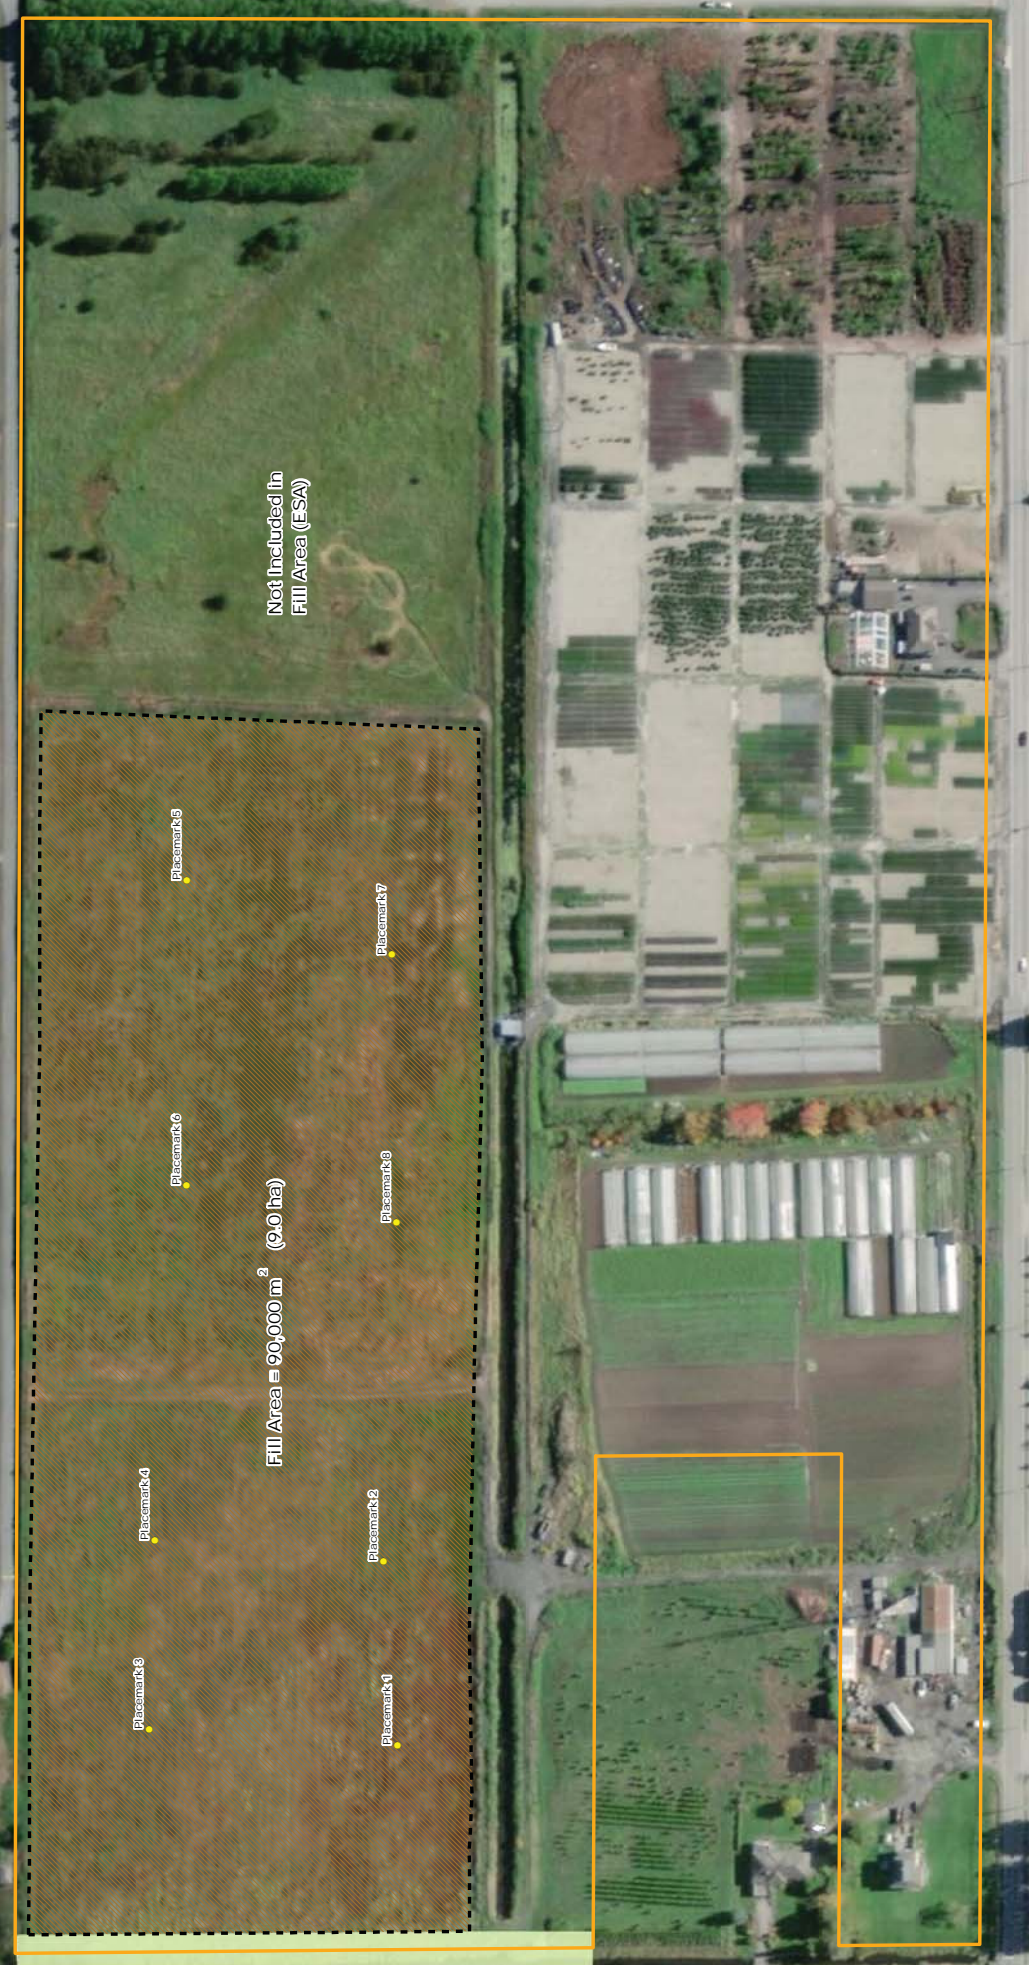
**FIGURE 3 : Soil Deposit Plan & RMA Setback**

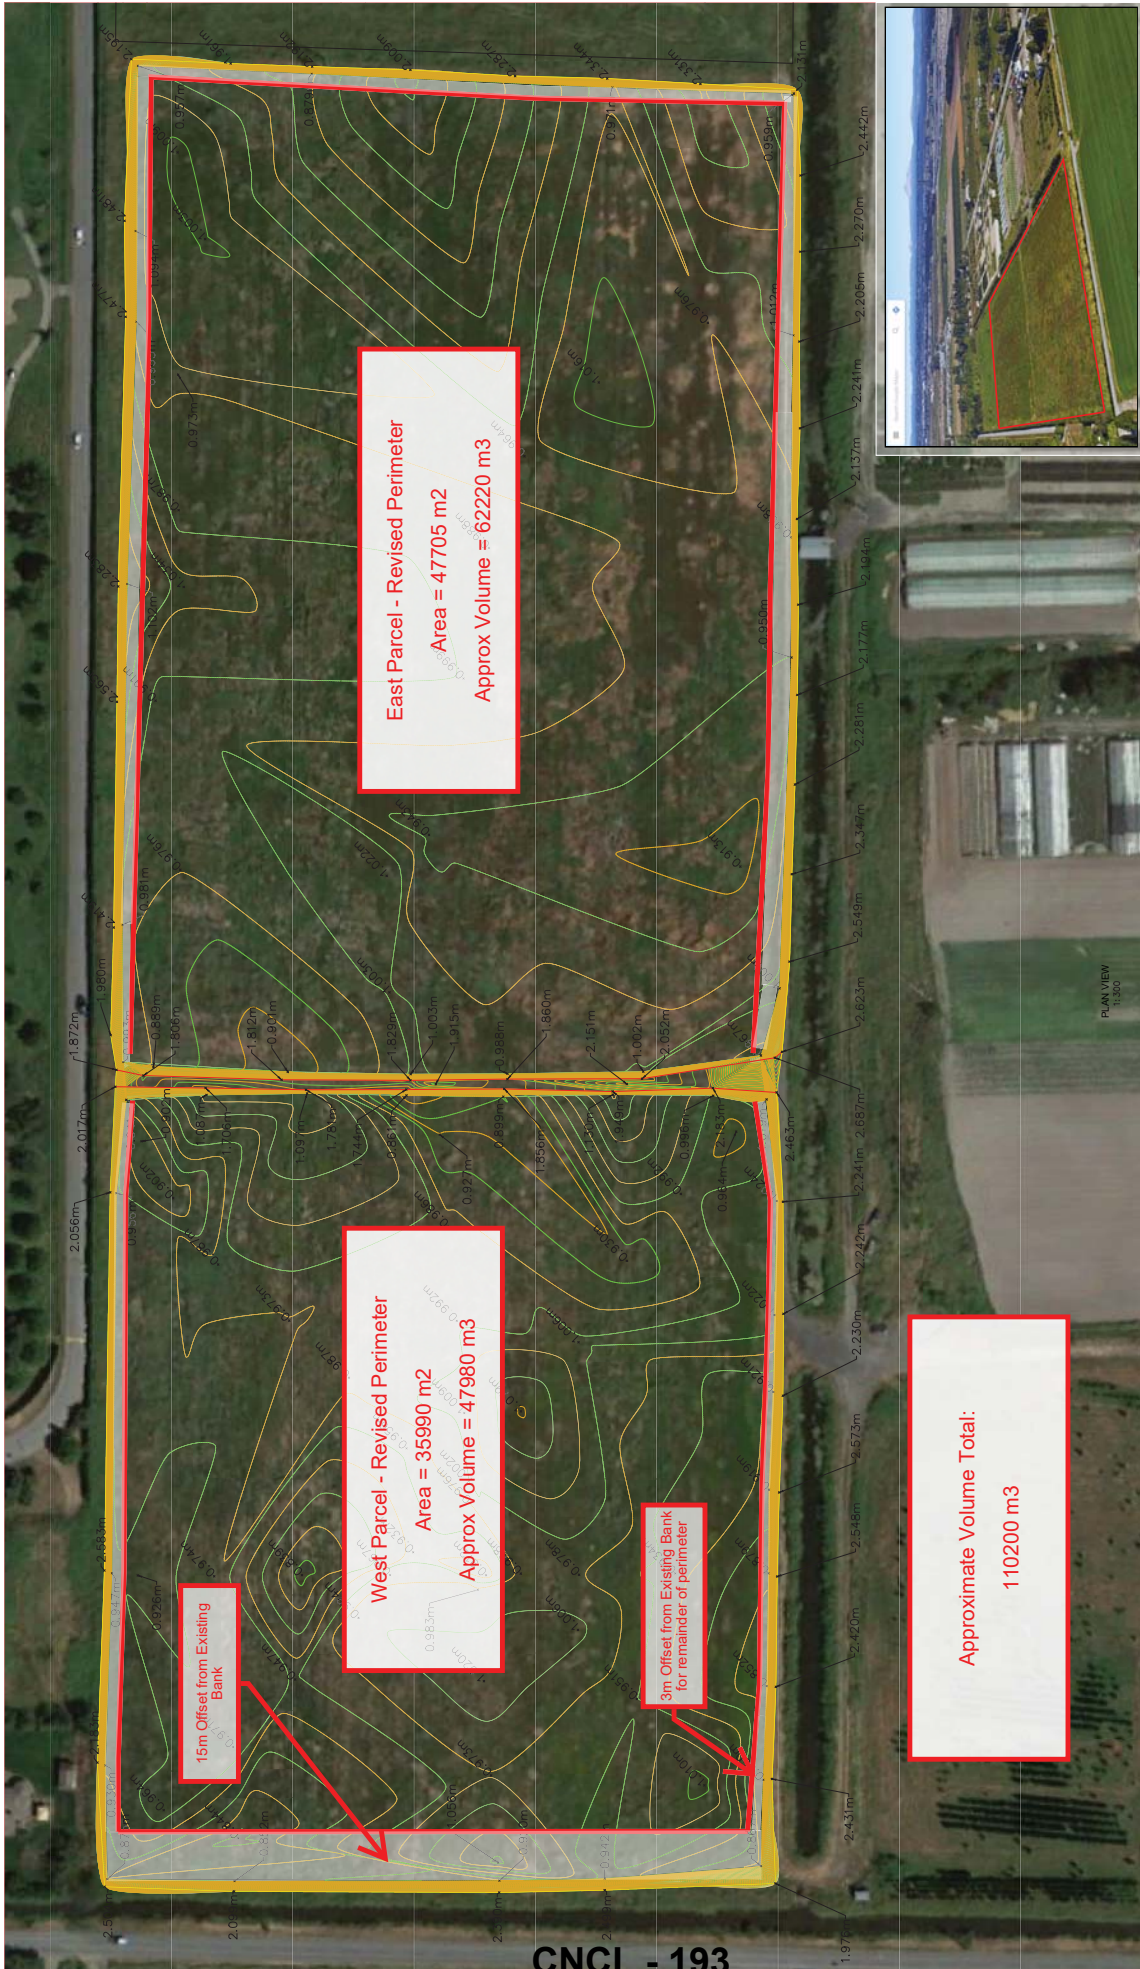
**East Parcel - Revised Perimeter**  
 Area = 47705 m<sup>2</sup>  
 Approx Volume = 62220 m<sup>3</sup>

**West Parcel - Revised Perimeter**  
 Area = 35990 m<sup>2</sup>  
 Approx Volume = 47980 m<sup>3</sup>

**Approximate Volume Total:**  
 110200 m<sup>3</sup>

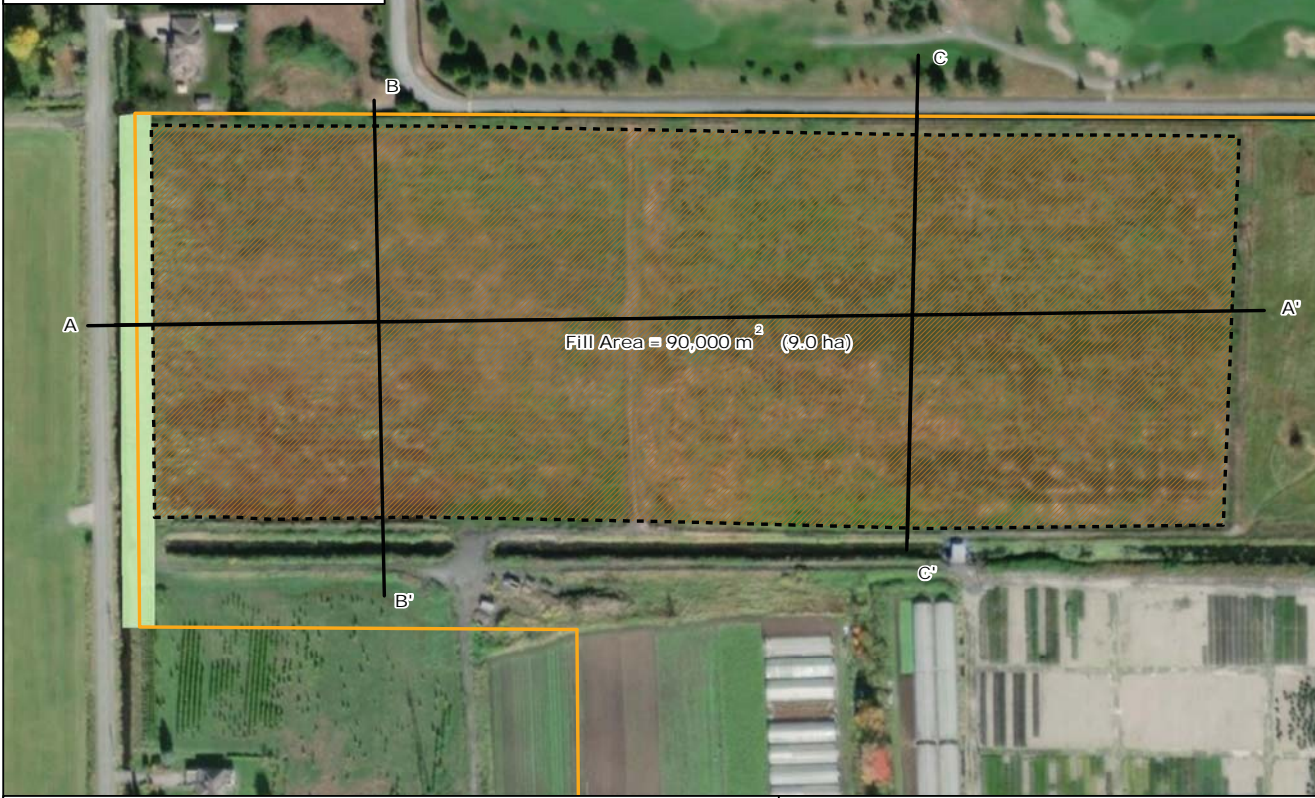
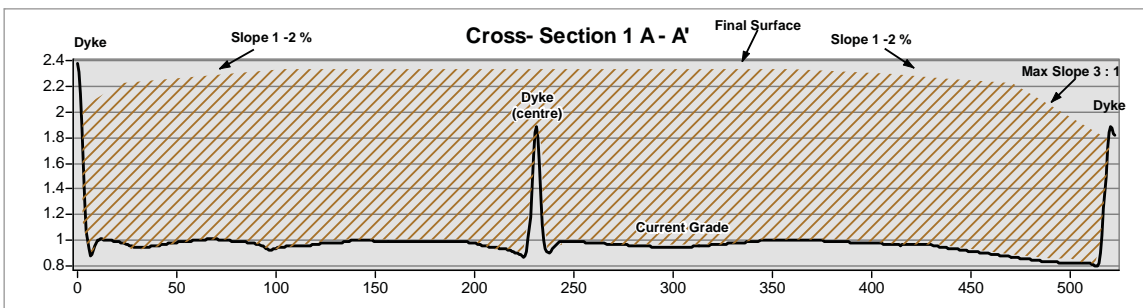
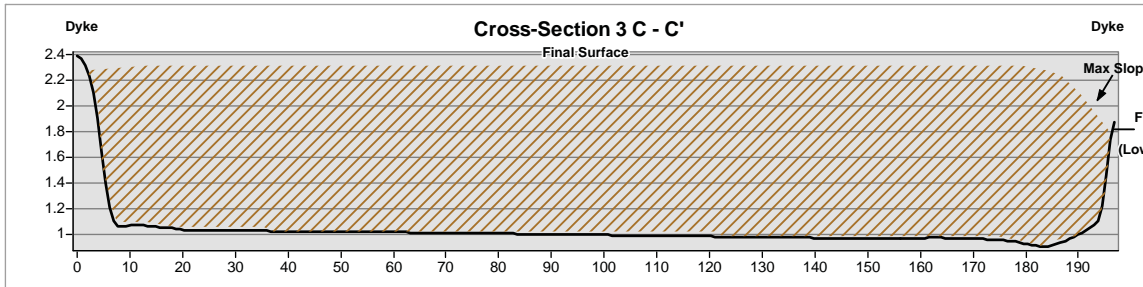
**FIGURE 5: Cross-Sections**

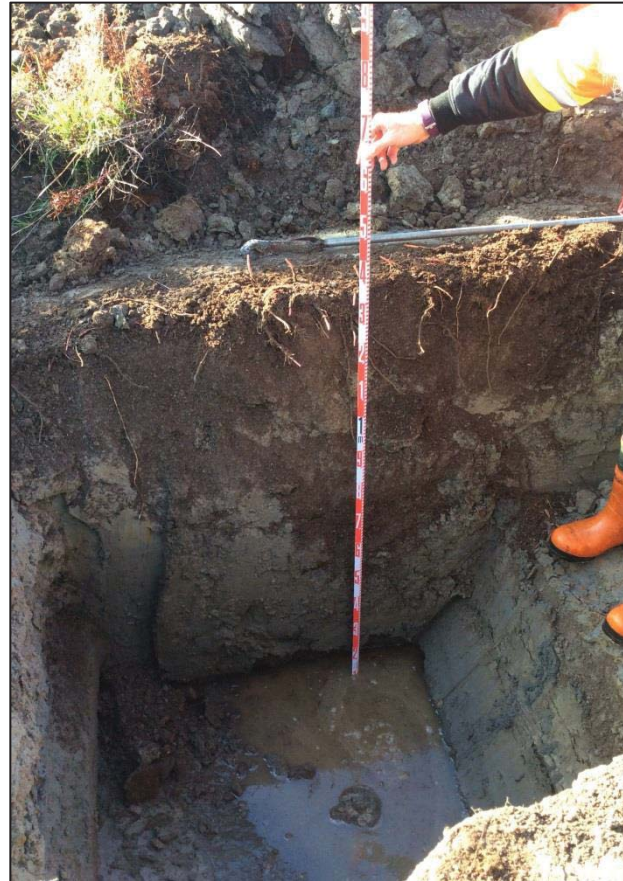
Property	Value
Pit Depth	1.3 m
# of soil horizons	5
Horizon	Depth (m)
Of	+12-0
Ap	0-0.2
Btg	0.2-0.6
IIBg	0.6-0.88
IICg	0.88-1.25
IIICg	1.25+
Water table depth	1.3 m
Soil type	Mineral with 12 cm of overlying peat
Overall classification	Orthic Luvis Gleysol
Parent material origin	Deltaic overbank deposits over fluvial sands
Land Capability (unimproved)	4W, 3D

Comments: 12 cm of reddish-brown to black fibric peat overlying. Mottling starts at 20 cm below the surface (oxidized root channels). Excess free water due to high water tables; surface water during growing season due to poor surface drainage. Water table encountered at 1.3 m. Btg horizon is a Silty Clay Loam that is firm to very firm. There are very few, very fine to fine roots in the Btg horizon. There is an undesirable soil structure limitation.

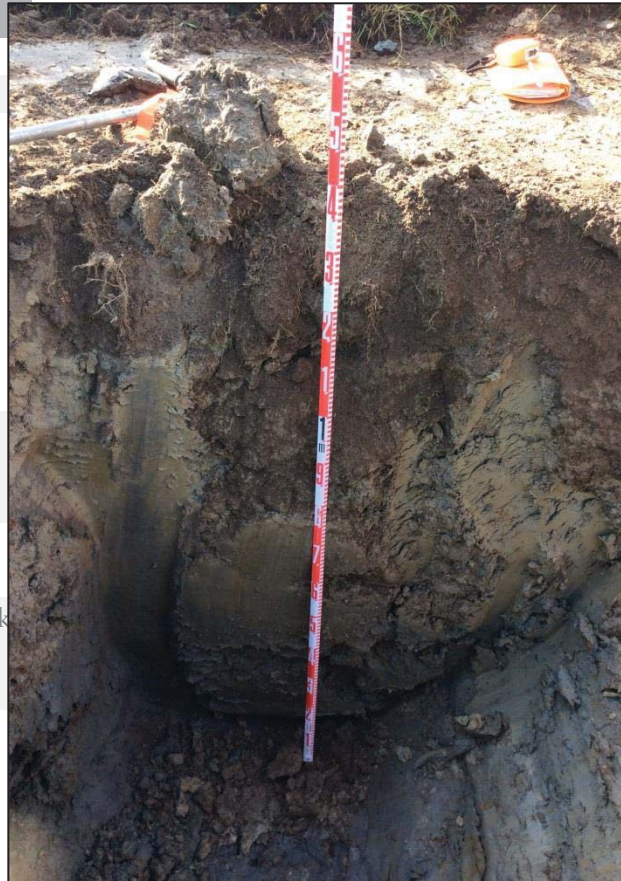
Property	Value
Pit Depth	1.3 m
# of soil horizons	4
Horizon	Depth (m)
Of	+12-0
Ap	0-0.25
Btg	0.25-0.57
BCg	0.57-1.12
IICg	1.12-1.3+
Water table depth	1.3 m
Soil type	Mineral with 12 cm of overlying peat
Overall classification	Orthic Luvisc Gleysol
Parent material origin	Deltaic overbank deposits over fluvial sands
Land Capability (unimproved)	4W, 3D

Comments: Same Btg horizon as Pit 1 – firm to very firm with oxidized root channels. Silty clay loam (light grey, faint blue mottles) grades to silt loam (medium grey, prominent orange mottles). Mottling (faint) starts at 25 cm below the surface.

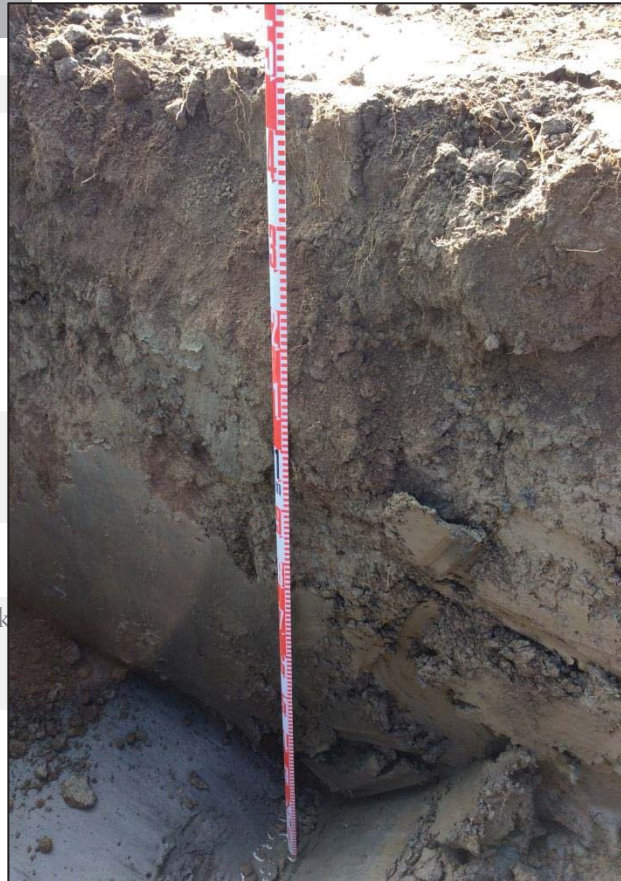
Property	Value
Pit Depth	1.4 m
# of soil horizons	4
Horizon	Depth (m)
Of	+10-0
Ap	0-0.3
Btg	0.3-0.8
BCg	0.8-1.3
Cg	1.3-1.4+
Water table depth	1.4 m
Soil type	Mineral with 10 cm of overlying peat
Overall classification	Orthic Luvisc Gleysol
Parent material origin	Deltaic overbank deposits over fluvial sands
Land Capability (unimproved)	4W, 3D

Comments: Mottling starts in Ap horizon (<30 cm); watertables are higher here during the growing season. The Btg horizon is firm to very firm (dense subsoil, root restricting layer).

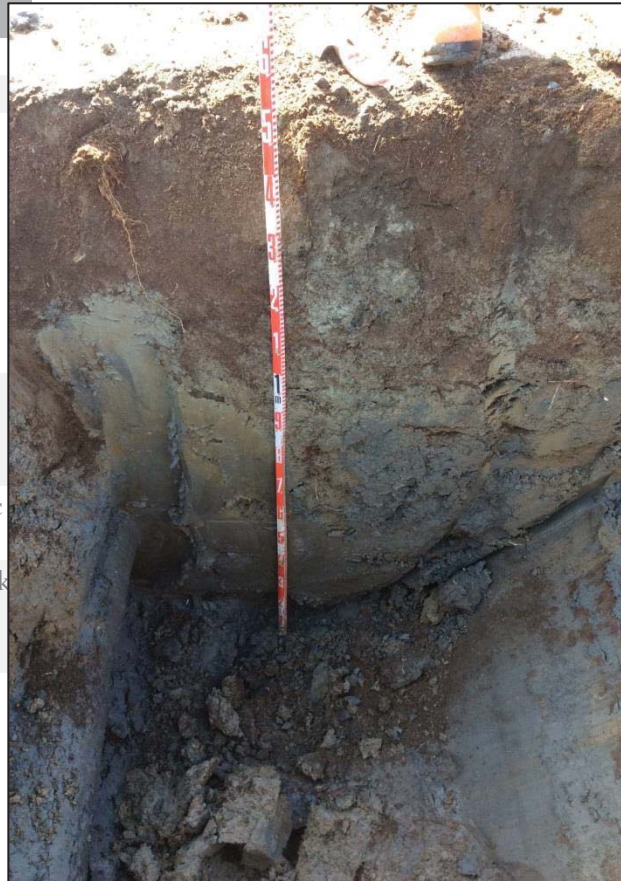
Property	Value
Pit Depth	1.4 m
# of soil horizons	3
Horizon	Depth (m)
Of	+10-0
Apgj	0-0.4
Btg	0.4-0.8
BCg	0.8-1.4+
Water table depth	Below 1.4 m
Soil type	Mineral with 12 cm of overlying peat
Overall classification	Orthic Luvisolic Gleysol
Parent material origin	Deltaic overbank deposits over fluvial sands
Land Capability (unimproved)	4W, 3D

Comments: Buried log encountered in Ap horizon (ploughed). Oxidized root channels and faint orange mottling in the Ap horizon; perched watertables during growing season indicated. No water encountered at bottom of pit.

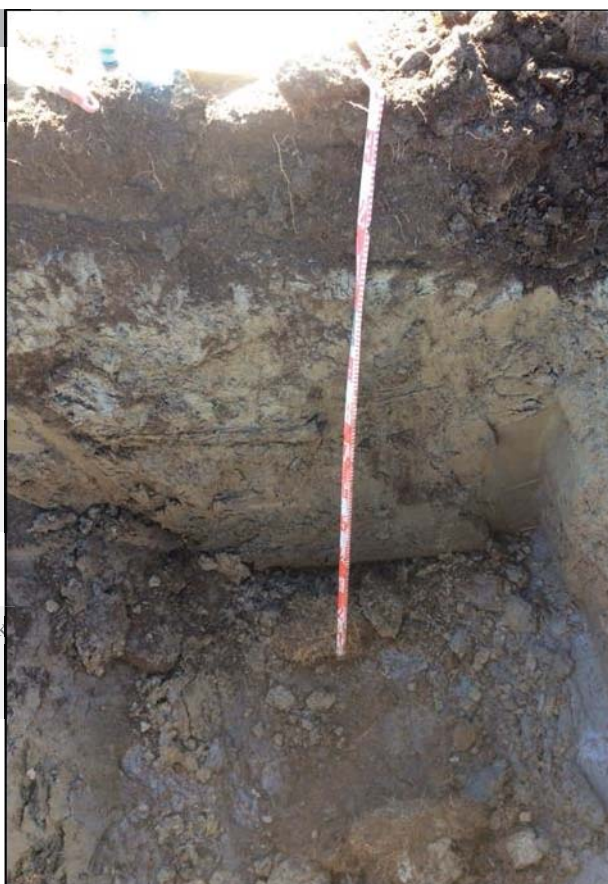
Property	Value
Pit Depth	1.4 m
# of soil horizons	4
Horizon	Depth (m)
Of	+10-0
Ah	0-0.15(0.3)
Btg	0.15(0.3)-0.66
BCg	0.66-0.96
Cg	0.96-1.4+
Water table depth	1.4 m
Soil type	Mineral with 12 cm of overlying peat
Overall classification	Orthic Luvic Gleysol
Parent material origin	Deltaic overbank deposits over fluvial sands
Land Capability (unimproved)	4W, 3D

Comments: The Ah horizon depth is variable; it is between 15 and 30 cm thick and the contact with the Btg horizon is wavy. Water was encountered at 1.4 m and quickly filled the pit. There was seepage in the BCg and Cg horizons. The BCg horizon is firm and the Btg is firm to very firm, as for the previous four soil pits. Mottling starts in the Btg horizon in this pit. Sand in Ah layer not native: brought for cranberry bog.

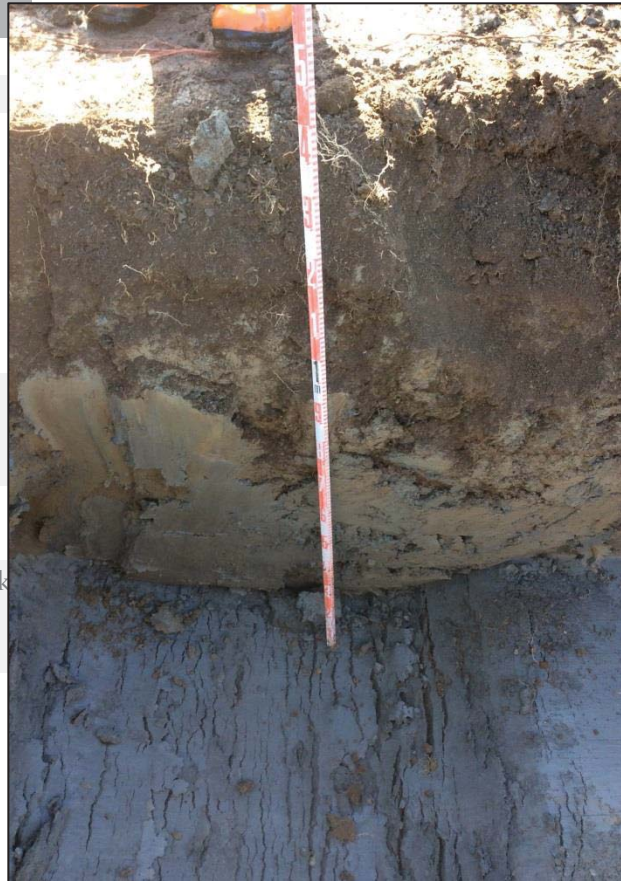
Property	Value
Pit Depth	1.2 m
# of soil horizons	
Horizon	Depth (m)
Of	+10-0
Ah	0-0.2(0.25)
Btg	0.2(0.25)-0.6
Bg	0.6-0.7
Cg	0.7-1.2+
Water table depth	1.2 m
Soil type	Mineral with 12 cm of overlying peat
Overall classification	Orthic Luvisc Gleysol
Parent material origin	Deltaic overbank deposits over fluvial sands
Land Capability (unimproved)	4W, 3D

Comments: Mottling within 20 cm of the surface (oxidized root channels and faint orange mottles). As for Pit 5, sand in Ah layer not native: brought for cranberry bog. Seepage at base of pit (1.2 m). As for previous pits, the Btg horizon is firm to very firm.

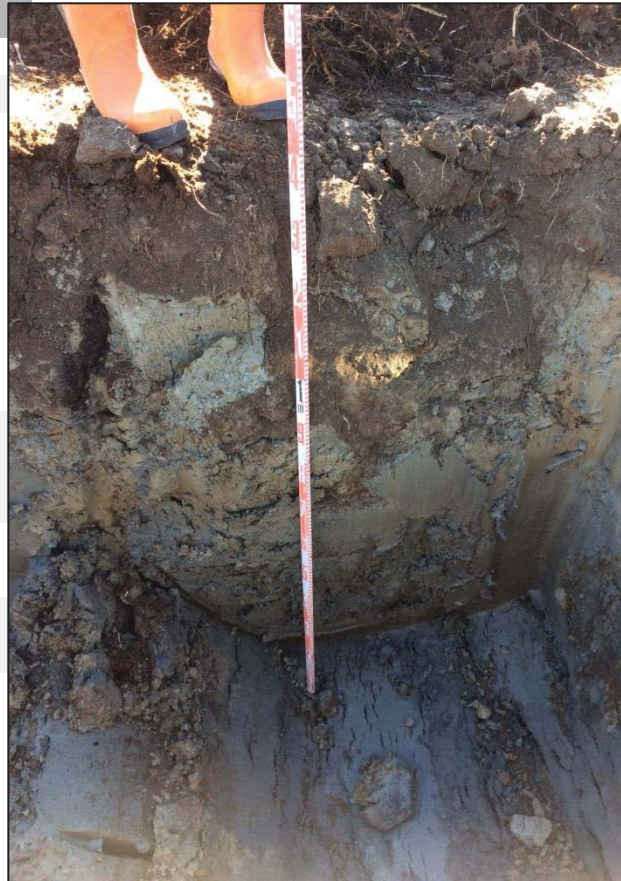
Property	Value
Pit Depth	1.3 m
# of soil horizons	5
Horizon	Depth (m)
Of	+12-0
Ah	0-0.12
Btg	0.12-7
Bg	0.7-1.3
Cg	1.3+
Water table depth	1.3 m
Soil type	Mineral with 12 cm of overlying peat
Overall classification	Orthic Luvisc Gleysol
Parent material origin	Estuarine environment
Land Capability (unimproved)	4W, 3D

Comments: Thin Ah layer here. Wood shavings at surface for cranberry farm. Btg is very firm. Mottling starts within 12 cm of the surface. Estuarine environment suggested in lower C horizon; poorly-graded and well-sorted sand. There is decomposed plant matter in the Bg horizon.

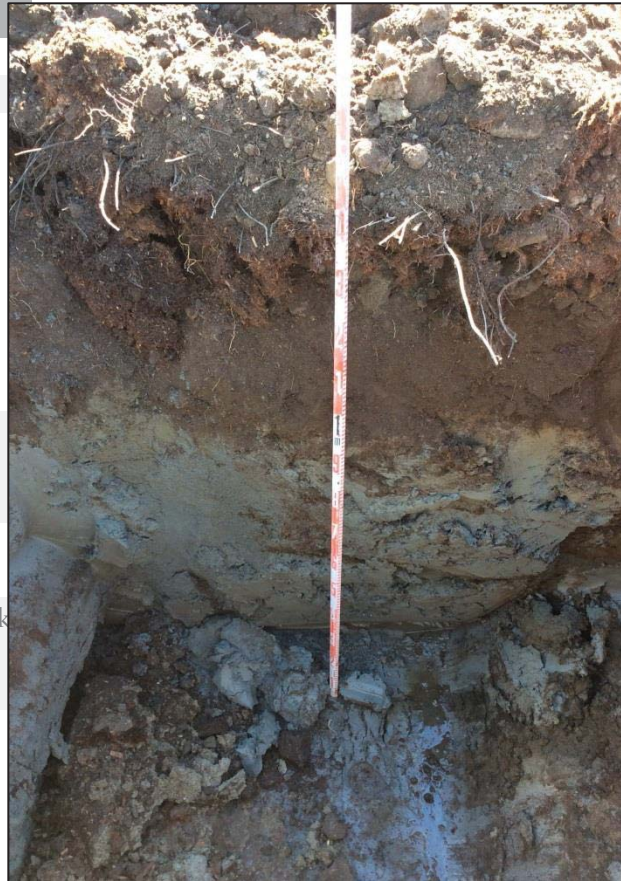
Property	Value
Pit Depth	1.6 m
# of soil horizons	5
Horizon	Depth (m)
Of	+20-0
Ap	0-0.6
Btg	0.6-0.95
BCg	0.95-1.5
Cg	1.5-1.6+
Water table depth	1.6 m
Soil type	Mineral with 12 cm of overlying peat
Overall classification	Orthic Luvisc Gleysol
Parent material origin	Deltaic overbank deposits over fluvial sands
Land Capability (unimproved)	4W, 2D

Comments: thickest Ah horizon encountered of all pits (as a result, dense subsoils are not encountered until 60 cm below the surface). Btg horizon is firm to very firm and grey with prominent orange mottles. Seepage at base of the pit.
