Report to Committee

Re:	Application by Dagneault Planning Consultants	Ltd. for	ALR Non-Farm Use at
From:	Wayne Craig Director, Development	File:	AG 18-842960
To:	Planning Committee	Date:	November 4, 2019

9500 No. 5 Road

The purpose of this report is to provide relevant updates to the April 2016 Agricultural Remediation Plan (ARP) that was prepared for the City of Richmond (CoR) and the Agricultural Land Commission (ALC). This report summarizes the findings of eight documents prepared by McTavish that were previously submitted to the CoR. This document also provides an updated drainage plan that includes the removal of the previously designed open drainage ditch on the southern side of the property and instead recommends the installation of subsurface drainage that will discharge into the King Road ditch. This change improves the overall drainage and maximizes the area available for agricultural production.

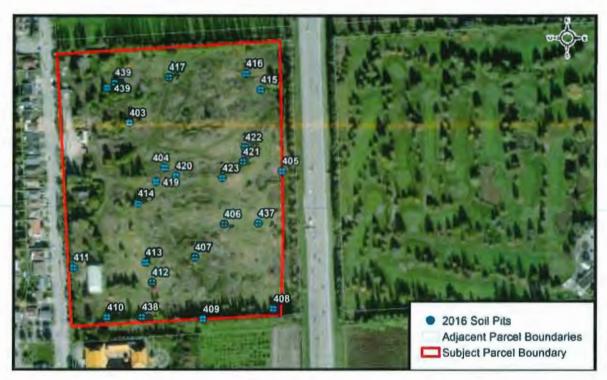
Figure 2: Soil sample locations 2016

Aggregate samples were taken from both the A and B horizon from each soil pit and laboratory tested at Exova Laboratory Inc. (now Element Materials Technology) in Surrey BC for macro/micronutrients as well as organic matter, electrical conductivity (EC) and acid reaction (pH).

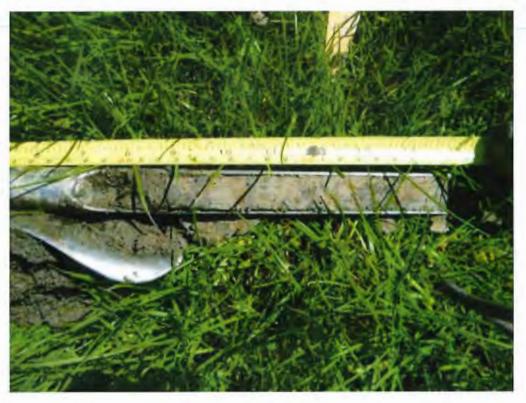
Figure 3 Soil sample showing mottled Bg horizon

Figure 3 shows a typical sample of the soils found on the site.

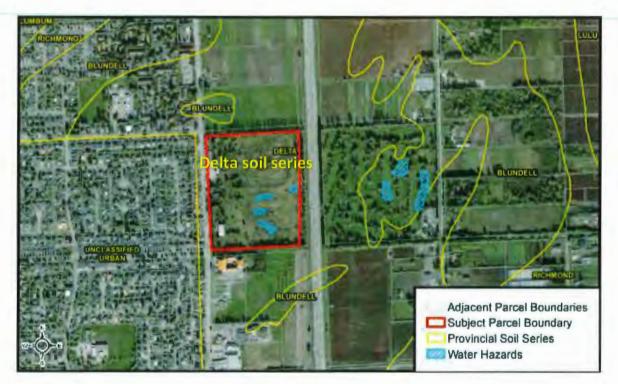
Figure 4 Mapped soil series at 9500 No. 5 Road, Richmond BC

horizon) is underlain by a gleyed Bg horizon which is typically grayish-brown, firm to very firm, silty/clayey zone, about 30 cm thick which breaks to prismatic or blocky clods and contains some reddish-brown mottles. Underlying this is a Cg horizon about 30 cm thick of dark gray or grayish-brown, massive silty material containing common mottling. Below 100 cm is typically saline, sandy or silty material. The lower part is also often saline and high in sulphur compounds. The soil series is classified as an Orthic humic Gleysol: saline phase, and typically has an extremely to very strongly acid reaction throughout the soil profile." Figure 3 shows the soil profile of the Delta soil series as found on the subject property.

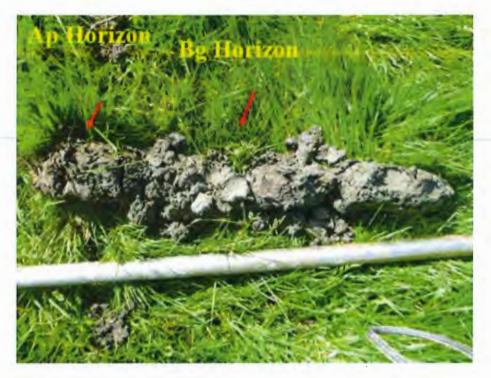
Figure 5 Typical soil profile of fairways

because there was a clear Ap horizon; however, the samples are lower in organic matter and higher than normal in sand for Delta soils. This is probably due to sand topping of the fairways in an attempt to improve drainage.

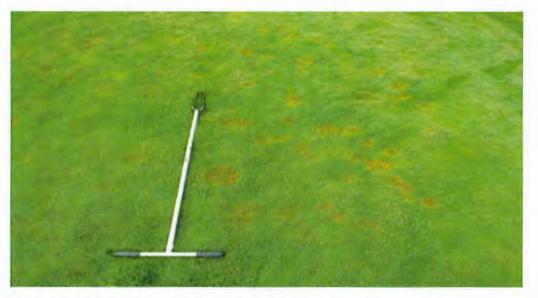
Figure 6 Reddish-brown spots indicating fungal disease on greens

All greens were impacted by fungal infections (see reddish-brown spots, Figure 6). A number of fungal diseases are common on bent grass golf greens these include dollar spot, pink snow mold (*Microdochium* patch and *Fusarium* patch), *Anthracnose*, and *Pythium* diseases (including *Pythium* blight and *Pythium* root rot or dysfunction). The obvious presence of fungal disease indicates that the golf course would have had a fungal control program that would have included extensive use of fungicides to control these diseases when the course was in operation. The major concern in terms of agricultural conversion of the golf course is not the actual presence of fungal diseases, but the types of fungicides that may have historically been used for control.

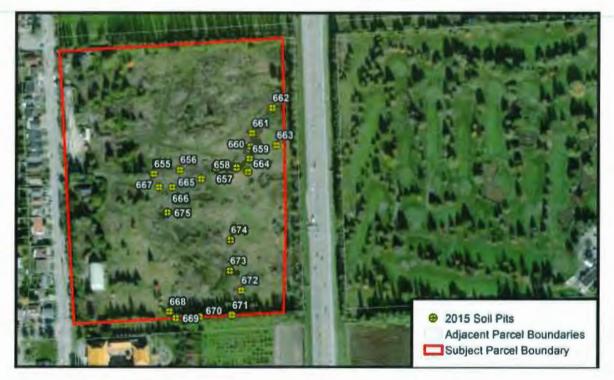
Figure 7 Sample locations 2015

Twenty trenches were excavated in 2015 as shown in Figure 7. A small amount of asphalt was observed at GPS location 655 and 657. All other trenches were free of any foreign material.

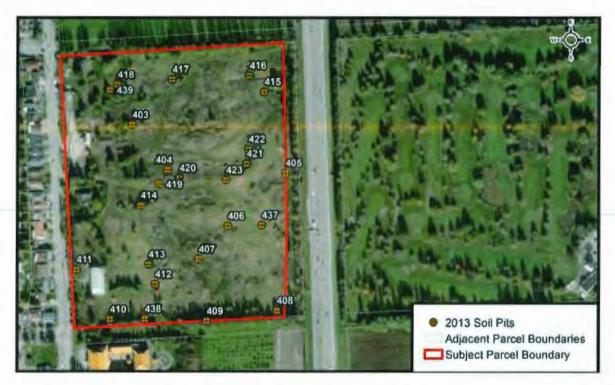
Figure 8 Sample locations 2013

The 2013 sampling indicated that the large berm running east to west along fairway 14 (GPS locations 419 to 421) contained occasional pieces of concrete and asphalt (consistent with 2015 findings). The soil in this berm also contains some gravel and is of a texture more consistent with glacial till. This berm turns north at sample location 421 (Figure 8) and 660 (Figure 7). The section of the berm running north is constructed with soil material from the subject property and can be used as topsoil.

The small amount of concrete and asphalt found in the berms are of no concern with respect to using the soil in the berms as fill material for the golf course water hazards. Even if there are small amounts of concrete or asphalt in this material, research has shown that aged asphalt and concrete do not leach significant quantities of deleterious material into the environment.

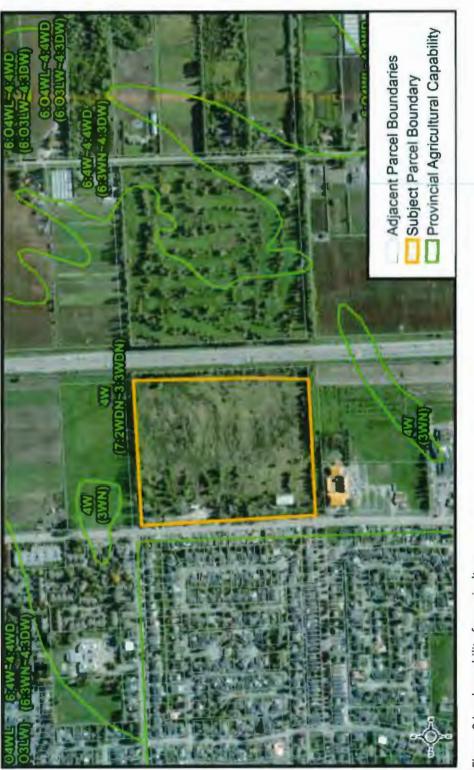
Figure 9 Land capability for agriculture

Site observations on the subject properties show soils to be consistent with the current land capability rating of 4W (Figure 8). Evidence of prolonged wetness was observed on many of the fairways. Mottling was present in many of the soil pits, indicating prolonged water saturation in the soil profile. This is common for Delta soils, which are classified as Orthic Humic Gleysol.

The site has been managed as a golf course for many years, and shallow subsurface drainage has been installed, however this is offset by very compacted soils and lack of freeboard for adequate drainage outlet depth at the Highway 99 ditch. Based on the saturated condition of the site observed during soil sampling in April 2013 and results of soil compaction testing in May 2013, it is the author's opinion that the site is presently a 4W classification.

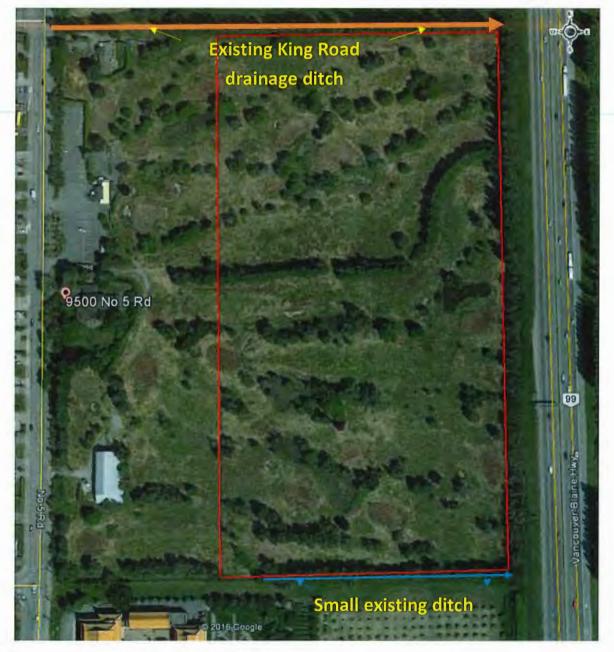
Figure 10 Location of surface drainage features

The sloping and crowning of the agricultural area will ensure that all surface drainage from the site flows to the Highway 99 or King Road drainage ditch. Water will be transmitted by the existing King Road ditch on the north of the property, and by subsurface drainage as described in section 5.5 of this report.

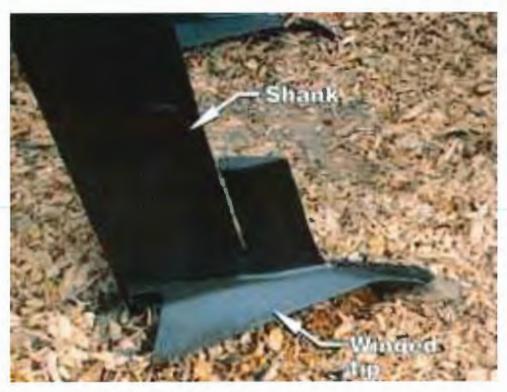
Figure 11 Example of a winged tine subsoiler

Deep compaction which restricts water infiltration and root development can be improved by subsoiling with a wing-tined subsoiler to depths of 0.75 m (Figures 11 and 12). Criteria for effective subsoiling include:

- Tine spacing must be at least 1 x the working depth of the subsoiler
- Subsoiling must be done when the soil is relatively dry
- Subsoiling will take place prior to the installation of the subsurface drainage system

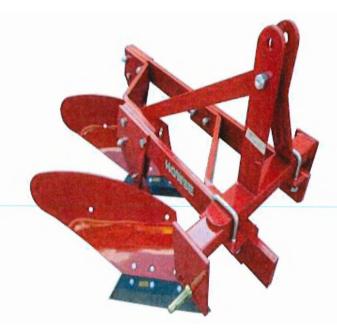
Figure 14 Moldboard plough

Ploughing should be done using a large mouldboard plough (see Figure 14) with a plough depth of at least 30 cm (12 inches).
